# Commissioning and Testing the 1970's Era LASS Solenoid Magnet in JLab's Hall D

J. Ballard, G. Biallas, G. Brown, D. Butler, T. Carstens, E. Chudakov, J. Creel, H. Egiyan, P. K. Ghoshal (*SMIEEE*), F. Martin, Y. Qiang, E. Smith, M. Stevens, S. Spiegel, T. Whitlatch and E. Wolin

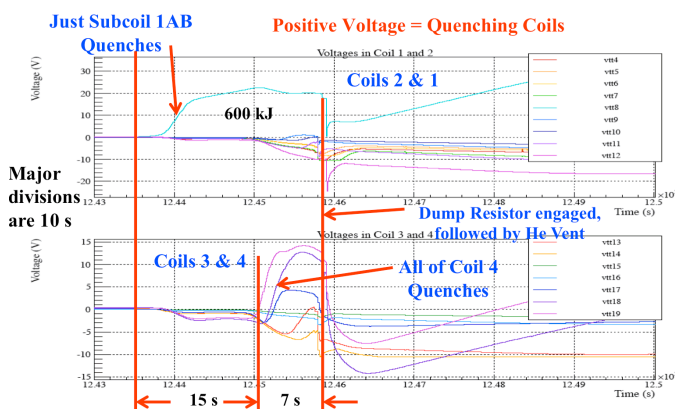
Fig. 3. Voltage tap readings during first 70 s after quench

Only Subcoil 1AB quenched in Coil 1 for the first 22 s while the adjacent turns of Coil 1, in the main helium chamber, remained superconducting. The Subcoil is housed in an antechamber, isolated from the main chamber with only four 5 cm x 2 cm openings to the main helium volume. Two of the openings are constricted to 3 cm x 1 cm by lead insulation.

After 15 s, a second quench engulfed the whole of Coil 4, even though its leads are thermally isolated from Coil 1. The compressing helium had raised the helium bath pressure to 1.44 Atm = 4.63 K.

Calculations show that the quench was not due to a short and that local heating didn't create a low liquid level in the Subcoil 1AB Antechamber. Problems with conductor damage, leads and splices are also not likely because of earlier running at 1500A.

Further analysis of raw, un-averaged voltage tap data showed small voltage spikes on voltage taps of other coils during ramping, perhaps indicating small movements. Unfortunately, Coil 1AB's voltage tap signal was too noisy to discern a similar (or bigger) voltage spike at the time of

quench. We believe heat from a large conductor motion is not ruled out as a cause of the quench.

Our analysis now shows that the conductor filament size is too large to inhibit flux jumps. The conductor specification didn't benefit from the theory of the use of small filaments because the theory was developed about the same time.

- We identified two possible explanations
- Solenoid will operate at  $\leq 1350\text{ A}$
