# Commissioning and Testing the 1970's Era LASS Solenoid Magnet in JLab's Hall D

J. Ballard, G. Biallas, G. Brown, D. Butler, T. Carstens, E. Chudakov, J. Creel, H. Egiyan, P. K. Ghoshal (*SMIEEE*), F. Martin, Y. Qiang, E. Smith, M. Stevens, S. Spiegel, T. Whitlatch and E. Wolin

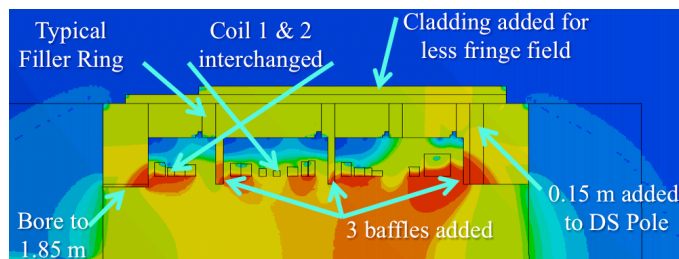
Fig. 2. A half solenoid cross section at 45° to the vertical with field profiles and yoke changes shown

Our design changes brought this force to the theoretical 22 kN range by interchanging Coils 1 and 2 and adding 76 mm thick iron irises with a 1.85 m bore (called baffles) in three locations. These may be seen in Fig. 2.
