Commissioning and Testing the 1970's Era LASS Solenoid Magnet in JLab's Hall D

Abstract—JLab refurbished and reconfigured the LASS 1.85-m bore Solenoid and installed it as the principal analysis magnet for nuclear physics in the newly constructed Hall D at Jefferson Laboratory. The magnet contains four superconducting coils within an iron yoke. The magnet was built in the early 1970s at Stanford Linear Accelerator Center and used a second time at Los Alamos National Laboratory. The coils were extensively refurbished and individually tested by JLab. A new Cryogenic Distribution Box provides cryogenics and their control valving, current distribution bus, and instrumentation pass-through. A repurposed CTI 2800 refrigerator system and new transfer line complete the system. We describe the reconfiguration, the process and problems of recommissioning the magnet, and the results of testing the completed magnet.

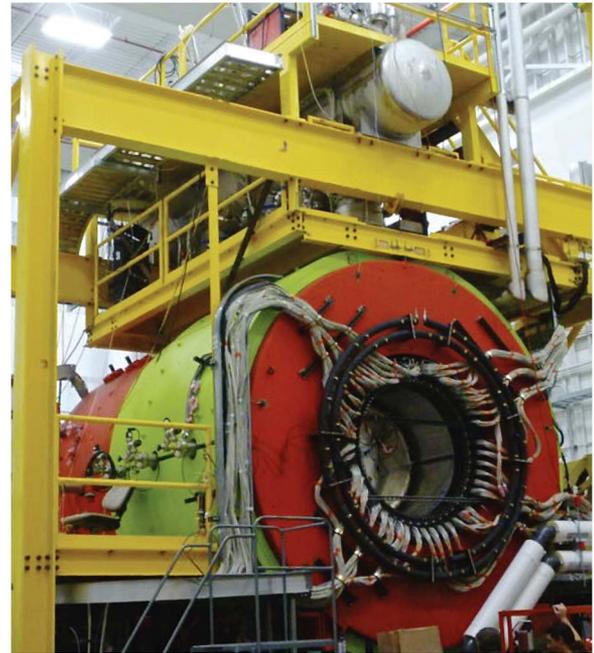
Fig. 1. Hall D Solenoid.

THE LASS Solenoid is the principle analysis magnet for the GlueX Experiment in Hall D at the Continuous Electron Beam Accelerator Facility (CEBAF) accelerator at Thomas Jefferson National Accelerator Facility (JLab) and is shown in Fig. 1. The Hall and recycled superconducting magnet were installed as part of the 12 GeV Upgrade [1]. The magnet was built at Stanford Linear Accelerator Center (SLAC) in 1971 [2] and reconstituted for the MEGA Experiment at Los Alamos in the 1990s. JLab refurbished, repaired and individually tested the coils and modified the yoke [3]. The magnet consists of four coils in series, contained within an iron yoke. See Table I for Parameters at SLAC and at JLab.
